# VIBRATION PERFORMANCE OF LONDON'S MILLENNIUM FOOTBRIDGE

The London Millennium Footbridge has an unusual low-slung suspension design, supported by steel cables anchored to piers on the opposite river banks. When opened in 2000, it was found that low-frequency lateral vibrations were excited by pedestrians. To reduce the amplitude of these swaying oscillations, modifications were made in two ways. One was to install, under the bridge deck, passive tuned-mass vibration absorbers of broadly conventional design. The other was to add damping by introducing linear viscous dampers. These modifications had to be made without altering the visual appearance of the bridge. That made the design of viscous dampers difficult because most of their only suitable locations were where the relative amplitudes of vibration were small. A key feature was therefore to deploy dampers that could work with very small amplitudes of movement. The design of both tuned-mass absorbers and viscous dampers will be reviewed. Proving tests, involving 2,000 people walking over the modified bridge, and the subsequent service experience, including the results of examinations by the manufacturers after 15 years' servi

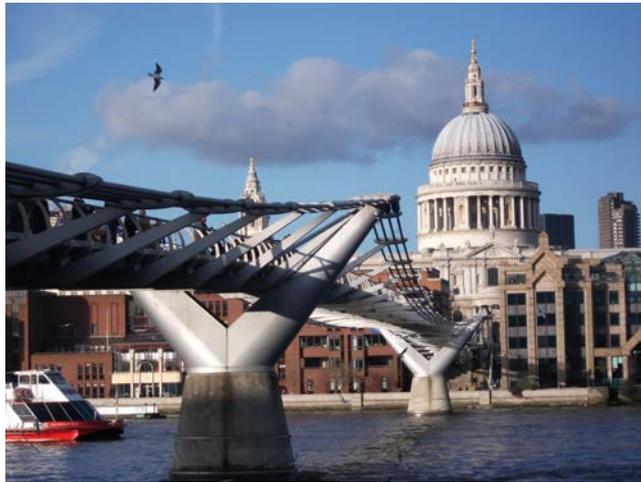
Figure 1: the London Millennium Footbridge

To mark the millennium, a new footbridge was built across the river Thames in London. Following a worldwide competition, the winning design team was led by architect Norman Foster, sculptor Anthony Caro and engineers Arup. Their design is a shallow suspension bridge over 300 metres long, with three spans, the longest, centre span, being 144 metres. The bridge's suspension cables sag only 2.3 metres and carry a high tensile load of approximately 2,000 tonnes. Detailed computational studies of the bridge dynamics were made, supported by wind tunnel tests on a 1:16 scale model, but the potential severity of human-induced vibration was not anticipated and what became known as the "Fujino effect" was not incorporated in relevant bridge design codes at the time.

When the bridge was opened, it was found to sway noticeably when crowded with walking pedestrians. The amplitude of this crowd-induced lateral vibration was large enough to cause concern that injuries might result, and immediately a decision was made to modify the bridge so as to reduce the amplitude as far as practicable. A very important proviso for all modifications was that, so far as possible, the much-praised elegant appearance of the bridge should remain unchanged. A two-fold approach was therefore adopted.

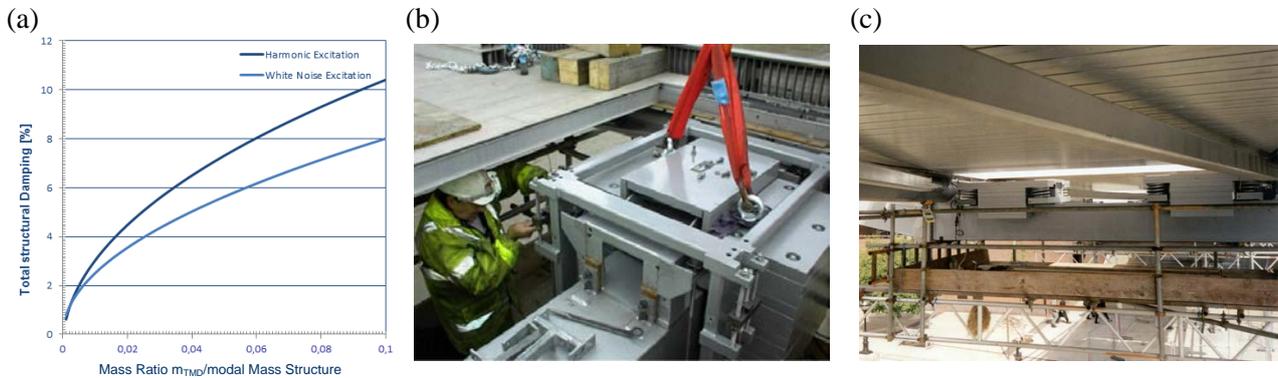
Figure 2: (a) typical additional damping vs. mass ratio achieved for random and harmonic excitation; and installation of (b) laterally- and (c) vertically-acting tuned-mass absorbers on the Millennium Footbridge.

The idea of tuned-mass vibration absorbers is over 90 years old and has been applied practically in structural engineering over the last 35 years or so. The governing parameter for an absorber and its efficacy – besides an optimum tuning frequency and damping ratio – is the ratio between the effective mass of the absorber and the modal mass of the relevant structural vibration mode. Figure 2(a) illustrates the additional structural damping that can be achieved in theory based on this mass ratio.

The proposed solution for the Millennium Footbridge included 26 pairs of vertically-acting absorbers, each with an effective mass of between 1 t and 3 t (mass ratio 3-5%) and four pairs of laterally-acting absorbers with an effective mass of 2.5 t (mass ratio 15%). The 11 different types of vertical absorbers are addressing vibration modes between 1.1 Hz and 2.2 Hz, with the lateral absorbers addressing the fundamental lateral mode at 0.48 Hz. The main challenge for the absorber design was to incorporate the devices aesthetically into the overall bridge design, and to keep the additional supporting steelwork at the bridge deck to a minimum. Several design approaches were considered, including a bi-directional absorber (vertically and laterally effective) but the final design was based on uni-directional units that could be attached directly to the main lateral members of the deck (see Fig. 2(b-c)).

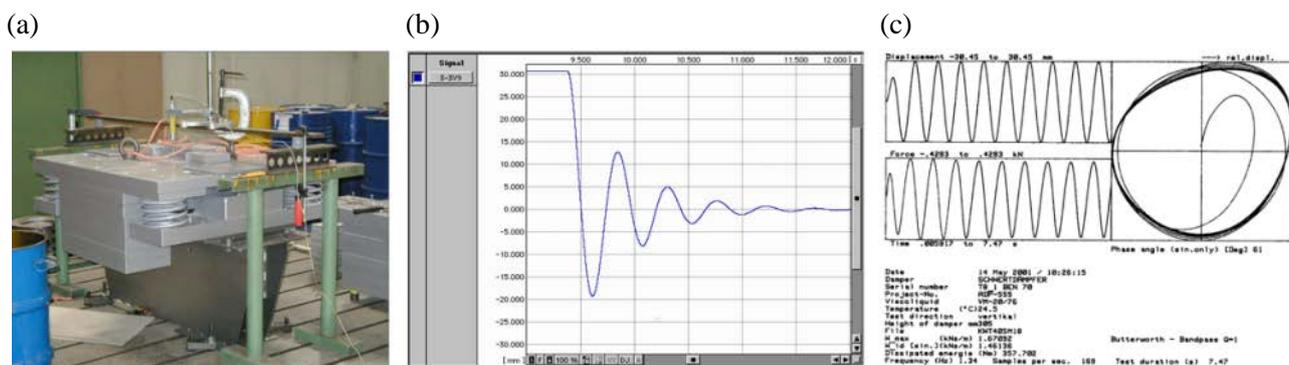
Figure 3: (a) workshop testing of a vertically-acting tuned-mass absorber, showing (b) the amplitude-time decay curves of the step response and (c) the force-deflection diagrams of the frequency response.

The key components of the absorbers – the springs and damping units – were tested separately at the factory, as well as the fully-assembled units. See Figure 3. The springs were tested for stiffness, and endurance tests were performed to ensure adequate fatigue life. Force-deflection tests were performed with the damping devices to verify the required damping ratio for a specified temperature range, and to verify that this ratio remains constant during long-term cyclic loading.

In addition, both the step response (Fig. 3(b)) and frequency response (Fig. 3(c)) of the fully assembled absorbers were measured to obtain the tuning frequency and damping ratio. The former involved measuring the amplitude-time decay of an absorber released from its position of maximum travel; the latter involved measuring the response to base excitation on a shake table.

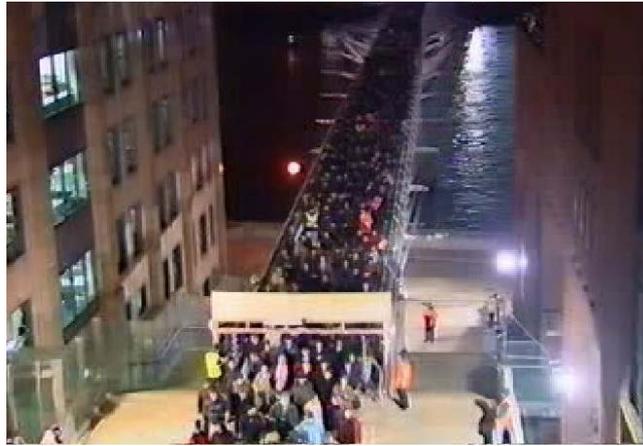
Figure 6: pedestrian acceptance tests demonstrated the success of the bridge modifications.

Because of the negative publicity that occurred when the bridge ‘wobbled’ on its opening day, its funding body, the London Millennium Bridge Trust, wished to make sure that, whatever calculations suggested, the modified bridge would perform satisfactorily when carrying a full load of walking pedestrians. It was therefore determined to carry out a full-scale test. For this purpose, some 2,000 people were assembled under cover of darkness one January evening in 2002. Starting from the south bank, they walked across to the north side of the bridge, where they reassembled before walking back to the south bank. Meanwhile the response of the bridge was monitored by numerous transducers whose output was logged. It was immediately seen that the target vibration limit of 0.02g r.m.s. below 1 Hz was being achieved.

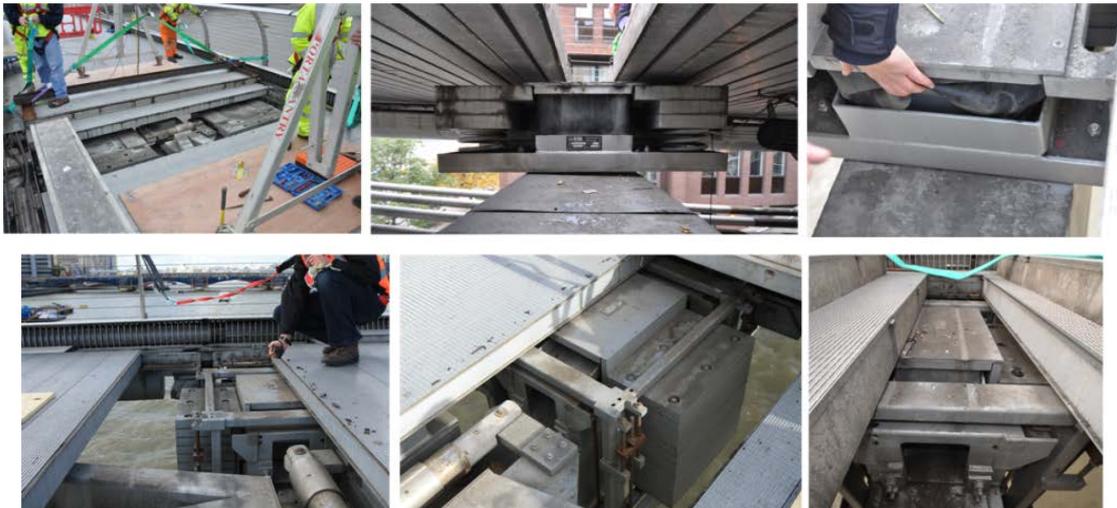
Figure 7: the inspection of the installed tuned-mass absorbers in 2012, showing (above) vertically-acting and (below) laterally-acting absorbers.

A random selection of the absorbers has been inspected regularly for corrosion and mobility since the reopening of the bridge, the last inspection being in October 2012 (see Fig. 7). In particular, the protective sleeves of the damping elements are checked for degradation and water ingress. All inspected absorbers have shown no significant corrosion, and the visual inspections of the damping elements have revealed no degradation, leakages or water ingress.
